Columbia Crew Survival Investigation Report

NASA/SP-2008-565

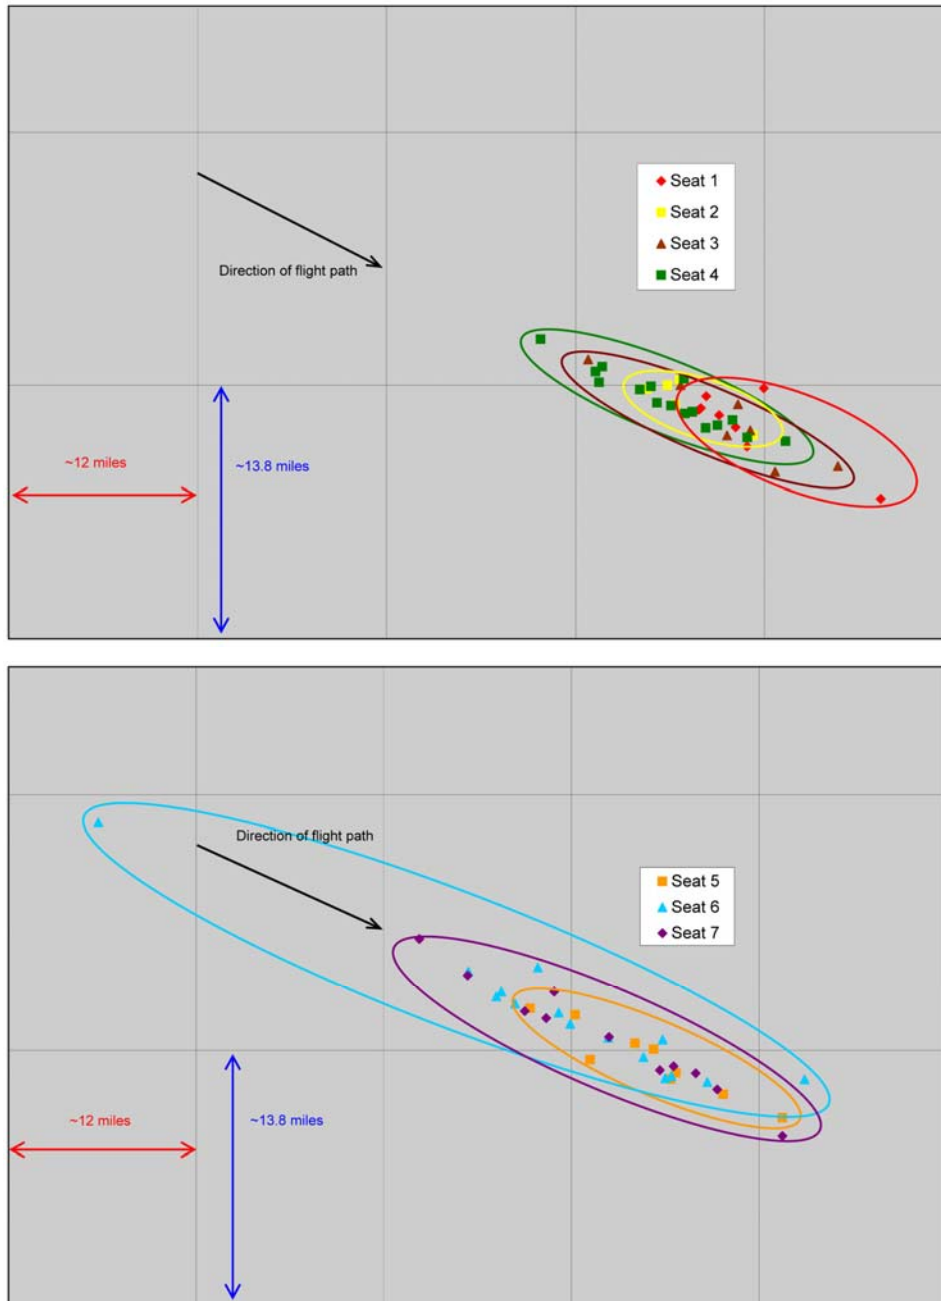
The investigation team concluded that the middeck crew members separated from the CM before the flight deck crew members. Orders within the middeck/flight deck groups cannot be determined conclusively, but it appears that seat 6 and seat 7 equipment items were first out of the middeck and seat 4 equipment was first out of the flight deck. All CEE associated with specific crew members was plotted by crew member. Analysis looking at the relative centers of the areas of recovered items for each crew member supports this conclusion. Figure 3.2-35 shows the locations of the recovered items for each crew member. The upper plot shows items for the flight deck crew members; the lower plot show items for the middeck crew members. Both plots are the same scale and represent the same geographic area.

Figure 3.2-35. *Relative locations of all crew escape equipment – flight deck crew members (top) and middeck crew members (bottom).*

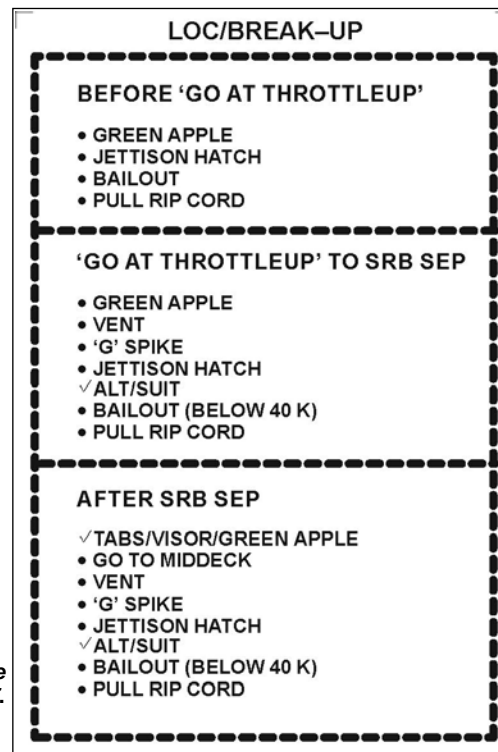
The emergency egress training program includes classroom sessions on shuttle CM egress procedures in the event of an LOC and vehicle breakup. This training is given to new astronauts as part of the ASCAN training program, and is given to flight-assigned shuttle crews in flight-assigned training just prior to launch in the escape systems refresher class. The training discusses procedures (figure 3.3-1) that are based on extrapolated data from the *Challenger* accident. The analysis of the *Challenger* data used basic assumptions for the vehicle/CM attitudes and dynamics.² However, this analysis had not been updated using the more sophisticated techniques available since the *Challenger* accident. Aerodynamic modeling performed for the current investigation provided estimates of CM dynamics following vehicle breakup. These dynamics differed from the assumptions that were made in the Shepherd-Foale Report, and have significant bearing on the LOC/breakup egress procedures. Additionally, the emergency egress procedures and training cover the case of a vehicle breakup during ascent,³ which has a relatively benign thermal environment when compared to the entry trajectories. The *Columbia* accident brought to the forefront the higher aerodynamic and heat stresses that adversely affect the shuttle CM survival (and, therefore, crew survival) found in the entry environment.

Figure 3.3-1. Loss of control/breakup cue card as flown on STS-107.

Recommendation L2-1. Assemble a team of crew escape instructors, flight directors, and astronauts to assess orbiter procedures in the context of ascent, deorbit, and entry contingencies. Revise the procedures with consideration to time constraints and the interplay among the thermal environment, expected crew module dynamics, and crew and crew equipment capabilities.

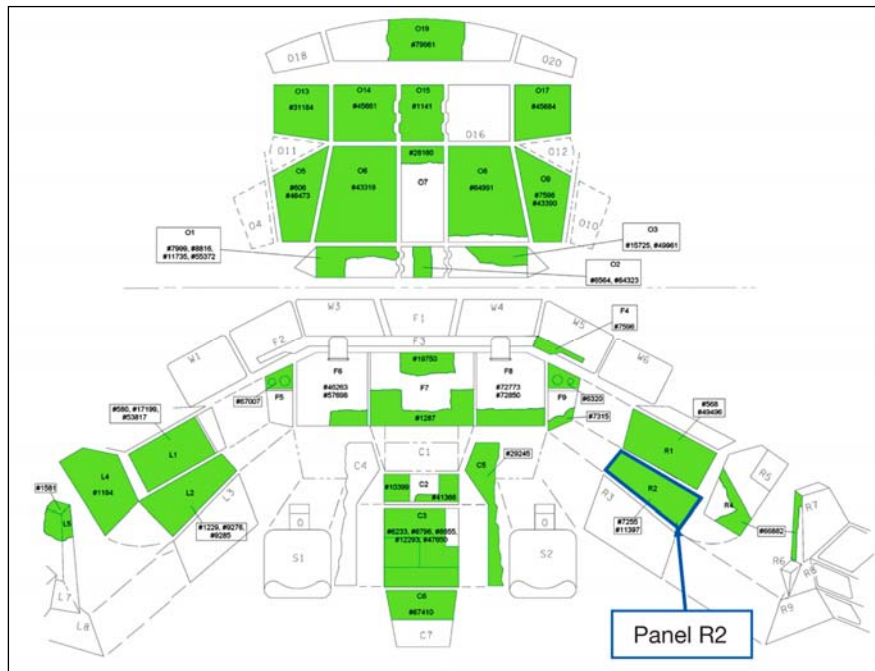
Figure 3.3-2. Columbia recovered flight deck forward panels (highlighted in green).

No further analysis was performed at that time as it was not possible to know whether the switch positions were due to crew action, the mishap, or handling during debris recovery. However, the R2 panel, to the immediate right of the PLT on the flight deck (figure 3.3-2), warranted further investigation. This panel contains the primary controls for the auxiliary power units (APUs). The APUs drive the hydraulic pumps that provide hydraulic pressure to the flight control surface actuators. During entry, these surfaces become increasingly important to vehicle control, and loss of hydraulic pressure can have catastrophic results. Reconstructed general purpose computer (RGPC)-2 data revealed that the hydraulic systems failed prior to GMT 14:00:03 while the crew was conscious and capable of taking action.

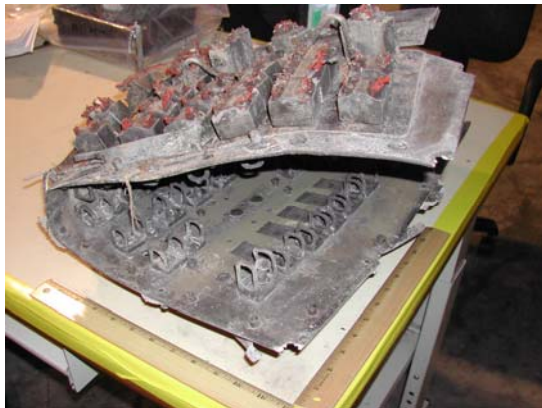
When recovered, the R2 panel was folded back in on itself (figure 3.3-3), protecting the innermost switches from manipulation during recovery operations. The switch positions were considered to be unaltered by external factors, making the switches valuable in determining crew actions.

Figure 3.3-3. Recovered R2 panel from Columbia.

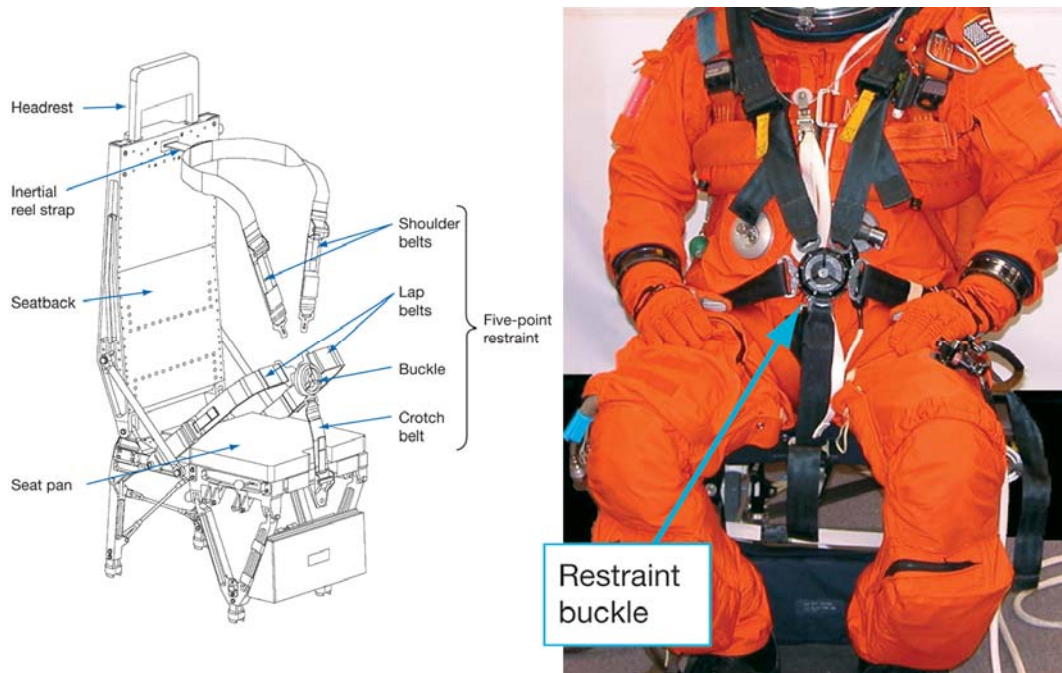
Figure 3.4-17. Detail of the five-point harness.

Engineering analysis of the STS-107 restraints indicates that most of the inertial reel straps were extended and did not lock or retract prior to failure of the straps. The inertial reels are normally unlocked to allow the crew to access displays and controls with a full range of motion. With the inertial reels unlocked, the crew members’ upper bodies were left unrestrained during the forebody dynamics. [REDACTED.]

Finding. Injuries were consistent with the crew’s upper bodies not being securely held to the seatbacks and with the evidence indicating that the inertial reel straps were extended at the time of failure.

Conclusion L2-3. Lethal injuries resulted from inadequate upper body restraint and protection during rotational motion.

Recommendation L2-8. The current shuttle inertial reels should be manually locked at the first sign of an off-nominal situation.

Recommendation L2-9. The use of inertial reels in future restraint systems should be evaluated to ensure that they are capable of protecting the crew during nominal and off-nominal situations without active crew intervention.

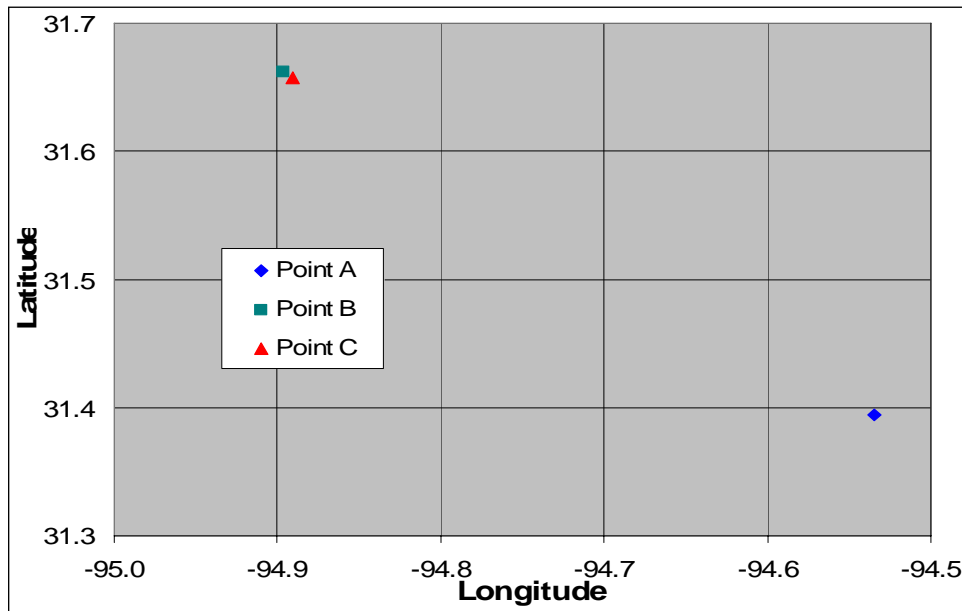
Figure 4-11. Plot for a pair of number strings that was interpreted for three different latitude/longitude formats.

Finding. The lack of a single, standard data format for latitude/longitude data and the potential ambiguity that is associated with the need to convert data of different formats resulted in possible data errors.

Figure 4-11 shows a plot for a pair of number strings (31 39439 and 94 53462) that is interpreted for three different latitude/longitude formats. Point A shows the numbers interpreted as the DD.ddddd format (31.39439° N, 94.53462° W). Point B shows the numbers as a DD MM SS.sss format (31° 39' 43.9" N, 94° 53' 46.2" W). Point C shows the numbers as a DD MM.mmm format (31° 39.439' N, 94° 53.462' W).

In this example, Point A is approximately 28 miles from Points B and C; while Points B and C are less than six-tenths of a mile apart. This example demonstrates the magnitude of error that can occur if the wrong data format is assumed and a necessary conversion does not occur (or an *unnecessary* conversion is performed).

Recommendation A10. Global Positioning System receivers used for recording the latitude/longitude of recovered debris must all be calibrated the same way (i.e., using the same reference system), and the latitude/longitude data should be recorded in a standardized format.
